# Storage Silos

## Case Study

6 x Storage Silos

PPG

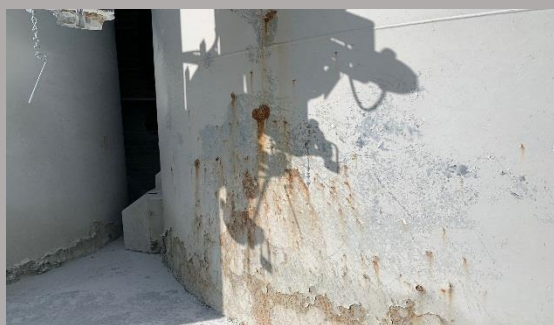
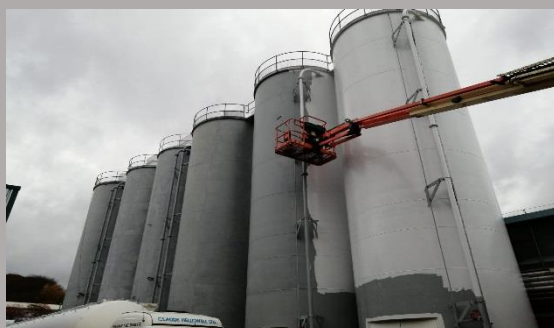
PPG have a number of storage silos which had been neglected for a number of years and desperately in need of some TLC.

3 silos were built more than 20 years previously, with a further 3 built around 10-12 years later. The original Silos showed significant damage, with the 3 newer assets in better condition. The roof sections were very badly corroded on all 6.

MCL Group were tasked with patch repair and priming the damaged and failing areas via mechanical prep to ISO8501-1 St3 and Sigmacover 350 aluminium primer.

A full abrade of all surfaces was then required to then apply a full coat of Sigmacover 350 and a top coat of Sigmadur 550.
