# Edinburgh University

## Case Study

Avian Research Facility

CS Group Armourglaze Reinforced Hygienic Wall System

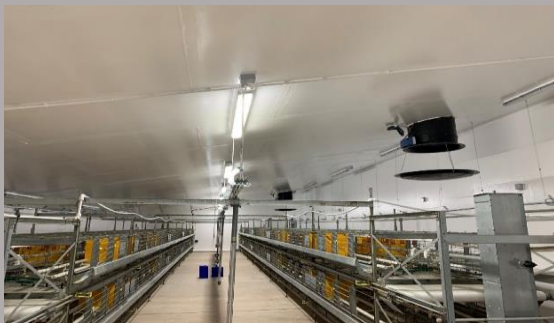
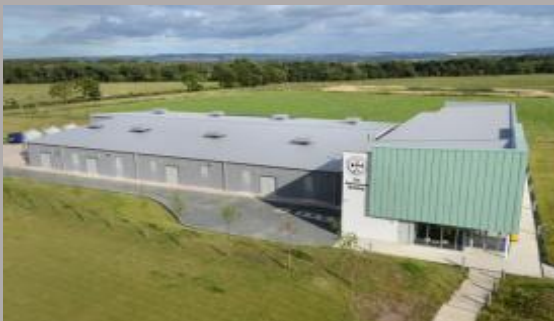
CS Group's reinforced Armourglaze system was chosen for the project with the double reinforcement applied to the walls and the single reinforcement to the ceilings.

A coat of primer is applied to all areas followed by 2 applications of the main body coat infilled with tissue and fibreglass matting and sealed with the gel coat, before 2 coats of the Armourglaze finish were applied to provide the chemical resistance,

Despite having to work around numerous penetrations for the heating and ductwork, as well expansion joints and the application of the reinforcement to the ceilings, this project was delivered and handed over on time.
