Manchester Arena

Case Study

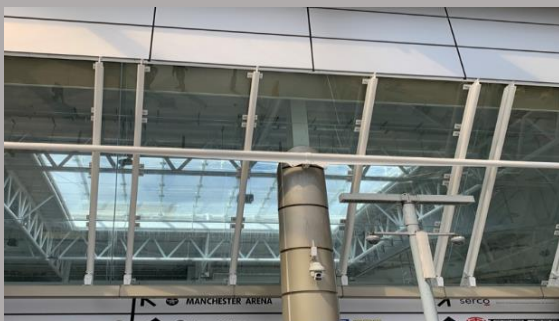
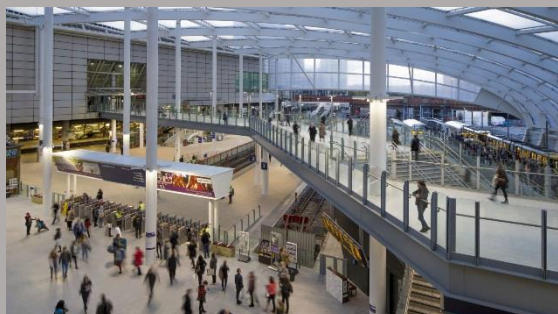
Following the terrorist attack at a concert in 2017, damage to the arena foyer roof steelwork and cladding was sustained, which, together with fumes and grime from the adjacent train station and restaurants, led the steelwork and cladding to the inside of the arena foyer to be in need of significant redecoration works.

There was also some external steelwork above the main central skylight which had degraded over the years which also required attention.

Due to the level of grime which had settled on the steelwork from the diesel fumes from the train station as well as the grease from a nearby fast food restaurant, a full detergent wash of the steelwork was required before anything else could be done. Following the clean-down, there was the small task of filling all of the holes caused by flying shrapnel from the bomb blast before the steelwork and cladding was all hand prepped to Iso8501-1 St2 and 2 coats of Jotun Pilot ACR were spray applied to completely rejuvenate the area.

Due to the regular concerts taking place throughout the week and weekends all work was carried out on nights immediately following any event. All work was carried out off MEWPs and temporary scaffolding with sheeting hung at the start of each shift to segregate areas and prevent over-spray. At the end of each shift, everything had to be removed from the area, and cleaned down ready for the events the following day/ evening.
